KOENIGS CREEK DAM

NDI NO. PA-00668

PHASE I INSPECTION REPORT  
NATIONAL DAM INSPECTION PROGRAM

Name of Dam: KOENIGS CREEK DAM  
State & State No: PENNSYLVANIA, 54-169  
County: SCHUYLKILL  
Stream: KOENIGS CREEK  
Date of Inspection: May 8, 1979

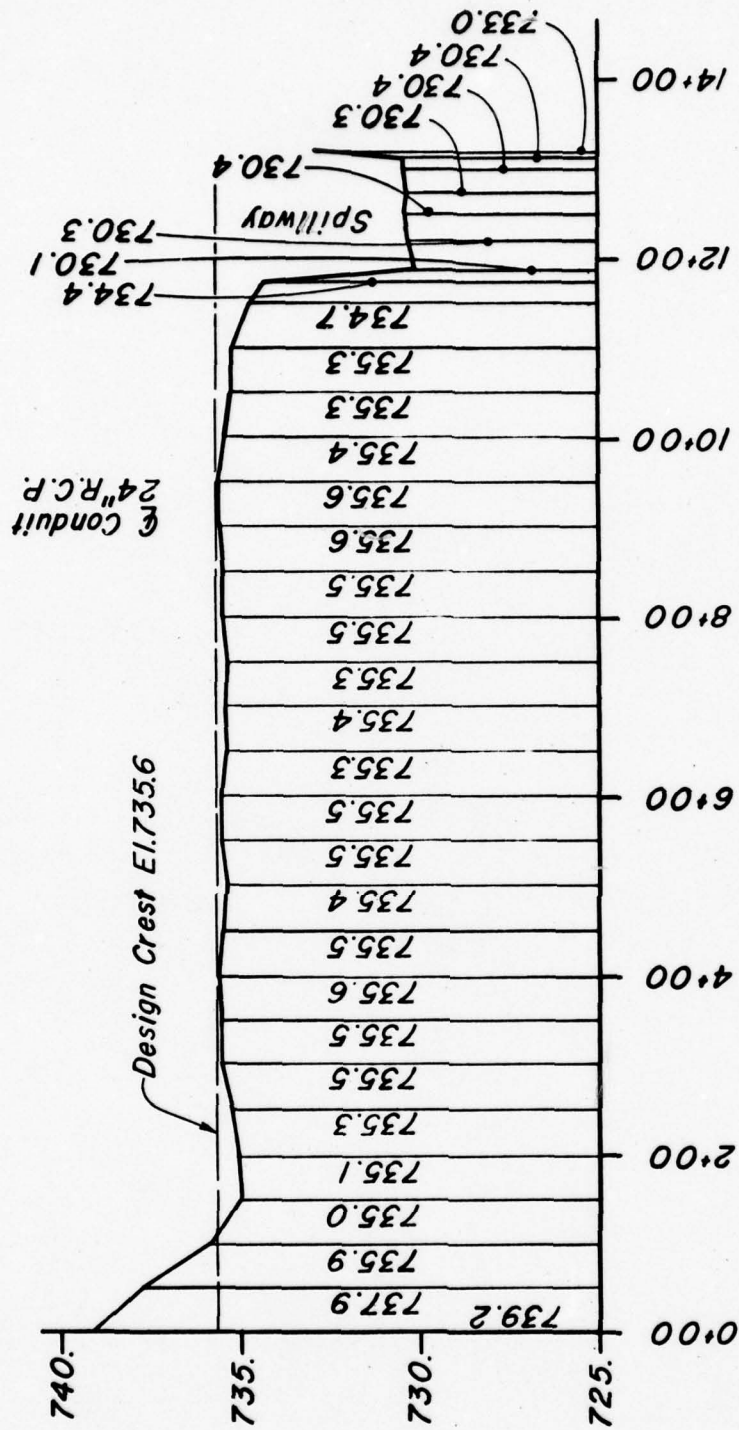
PLATE A-I

A surveyed profile along the crest of the dam shows a variation of 0.1 to 0.6 foot below the design elevation. The 0.6 foot occurs at only one point near the left abutment. The average deviation would be about -0.1 foot. The upstream and downstream slopes were found to be essentially as designed. Refer to Appendix A, Plates II and III for survey information and Appendix E for photographs of existing facilities.
